**MARYLAND HISTORICAL TRUST  
DETERMINATION OF ELIGIBILITY FORM**

Property Name: Staley-Summers House Property Inventory Number: F-2-110  
Address: U.S. 340 U.S. Route 340, Jefferson Pike Historic district: ☐ yes ☒ no  
City: Petersville Zip Code: 21716 County: Frederick  
USGS Quadrangle(s): Point of Rocks  
Property Owner: Maryland State Highway Administration Tax Account ID Number: N/A  
Tax Map Parcel Number(s): 32 Tax Map Number: 83  
Project: Staley-Summers Architectural Inventory Agency: Maryland State Highway Administration  
Agency Prepared By: A.D. Marble & Company  
Preparer's Name: Stephanie Foell Date Prepared: 12/28/2004  
Documentation is presented in: Companion MIHP form of the Staley-Summers Architectural Inventory  
Preparer's Eligibility Recommendation: ☐ Eligibility recommended ☒ Eligibility not recommended  
Criteria: ☐ A ☐ B ☐ C ☐ D Considerations: ☐ A ☐ B ☐ C ☐ D ☐ E ☐ F ☐ G  
*Complete if the property is a contributing or non-contributing resource to a NR district/property:*

## Maryland Inventory of Historic Properties Form

Staley-Summers House Property

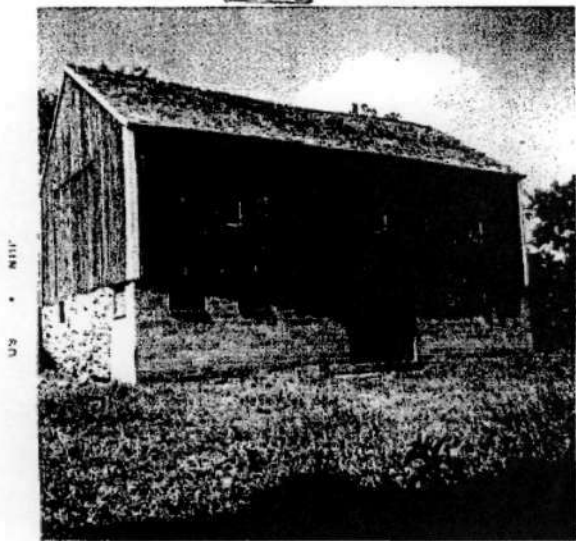
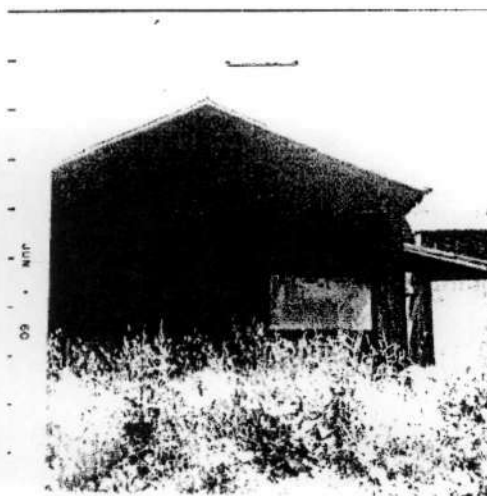
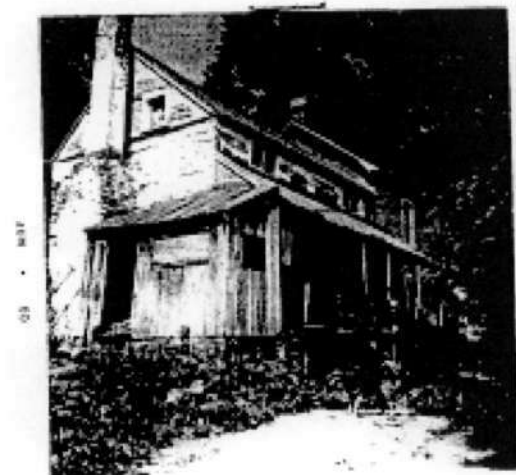
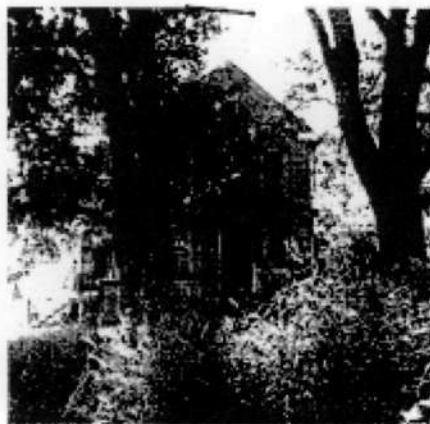
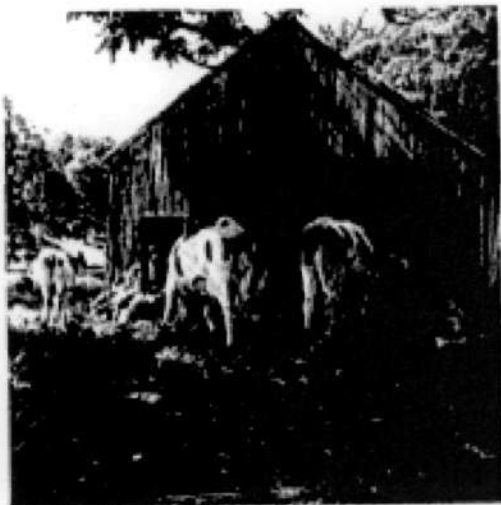
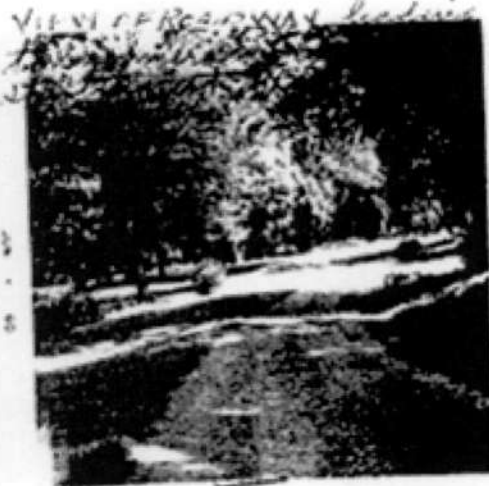
Staley-Summers House Property  
F-2-110  
Petersville, Frederick County, MD  
Photocopies of 1960 Photos, on file at SHA

A collection of photographs of the Staley-Summers House property that dates to the 1960s were consulted as part of the research for the present project. The photographs date to the time when SHA acquired the property. Photocopies of the original photographs were referenced for the building descriptions; however, the original photographs are on file at SHA, Office of Real Estate. The photographs reveal the former condition of the house and agricultural outbuildings, and depict the changes that have occurred in the past 40 years. Most notably, they demonstrate the lack of integrity of the property due in large part to the collapse of the agricultural buildings and the collapse of two porches and a wing of the residence.

The 1960 photographs of the log house portray that a later, two-story, wood-frame, clapboard wing was added to the east elevation. This addition has since collapsed and only the stone foundation remains extant. According to the photographs, the wood-frame addition was two bays wide by two rooms deep. Like the log house, the symmetrical orientation of the addition is also on an east-west axis and is a side-gable configuration. A full-width, wood-frame, shed-roof porch was featured on the east elevation. Access to this wing addition was from the east elevation, as the only entrance door visible in the photographs is centered below the porch roof on the east elevation. Fenestration on this addition is not clearly discernable from the quality of the photocopy of the original photographs; however, a double-hung window arrangement, with simple, wood trim surrounds is visible. The collection of photographs also verifies

that a porch over the centrally placed entrance door was on the front façade, approached by a flight of wood-frame steps. The photographs reveal that there was a brick chimney stack built upon the stone base on the west elevation. In addition, they depict an enclosed, frame-and-tin, shed-roof porch above the door on the west elevation, which is no longer extant.

Photographs (1960) of the bank barn reveal the superstructure was constructed of wood, with a centrally-placed wagon entrance on the south elevation. They also reveal that the cinder-block addition spanned the full width of the bottom portion on the south elevation.

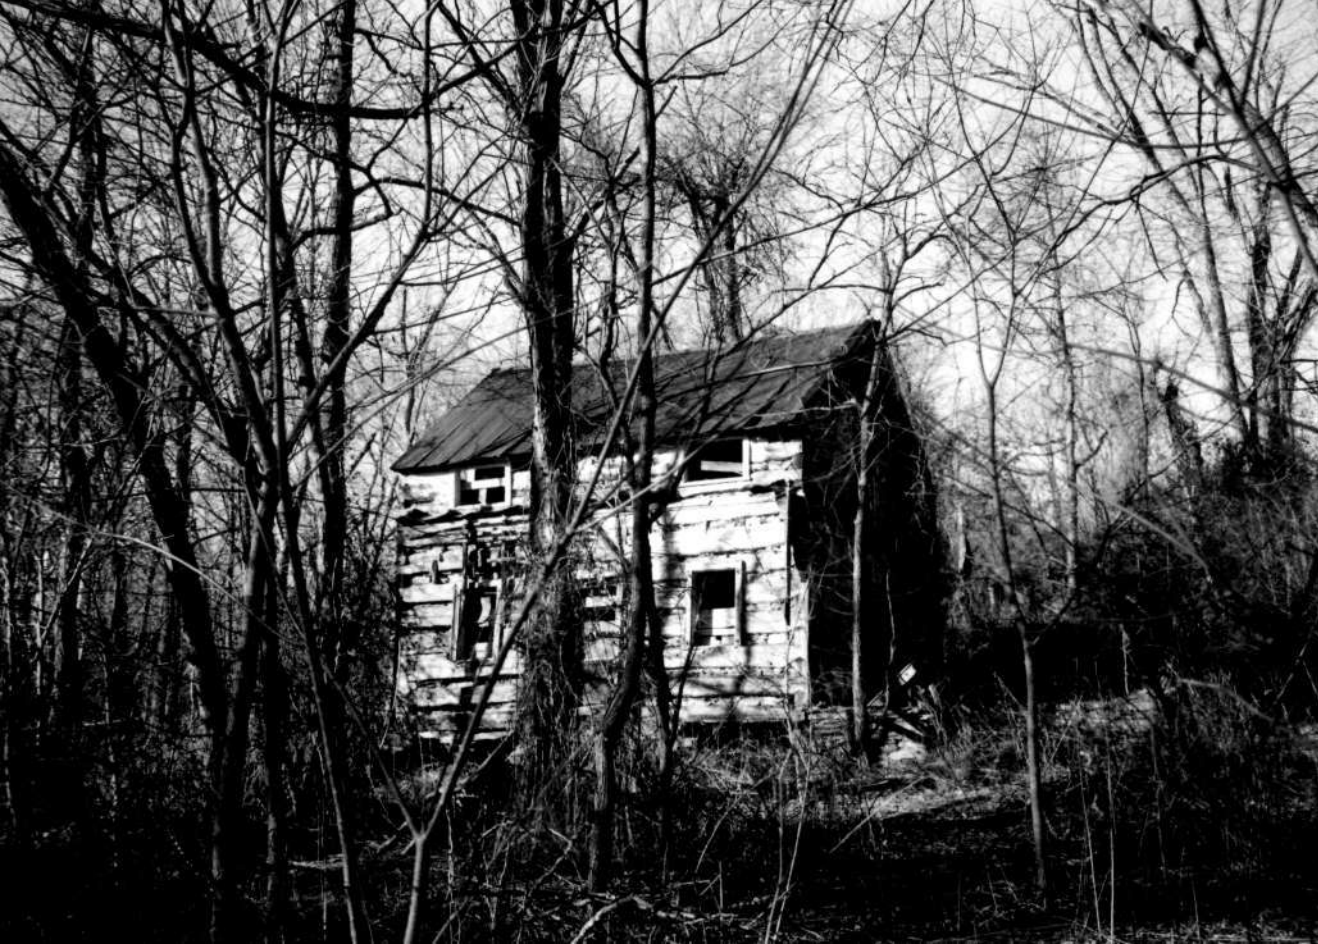
1/23

The east elevation was previously attached to an addition that has collapsed. The exterior of the east elevation reveals that the wood slats of the second story wall are horizontally oriented, opposite of those on first story. Furthermore, a juncture of mortise-and-tenon logs is located between the first and second stories, also evidence of a later, second-story addition to the log house. There are three door openings on this elevation. A side-entrance door is centered on the bottom half of the east elevation. The second story has two door openings below the gable roof line. These door openings were likely former windows identical to those on the west elevation before being modified.

Facade and east elevation  
of log house

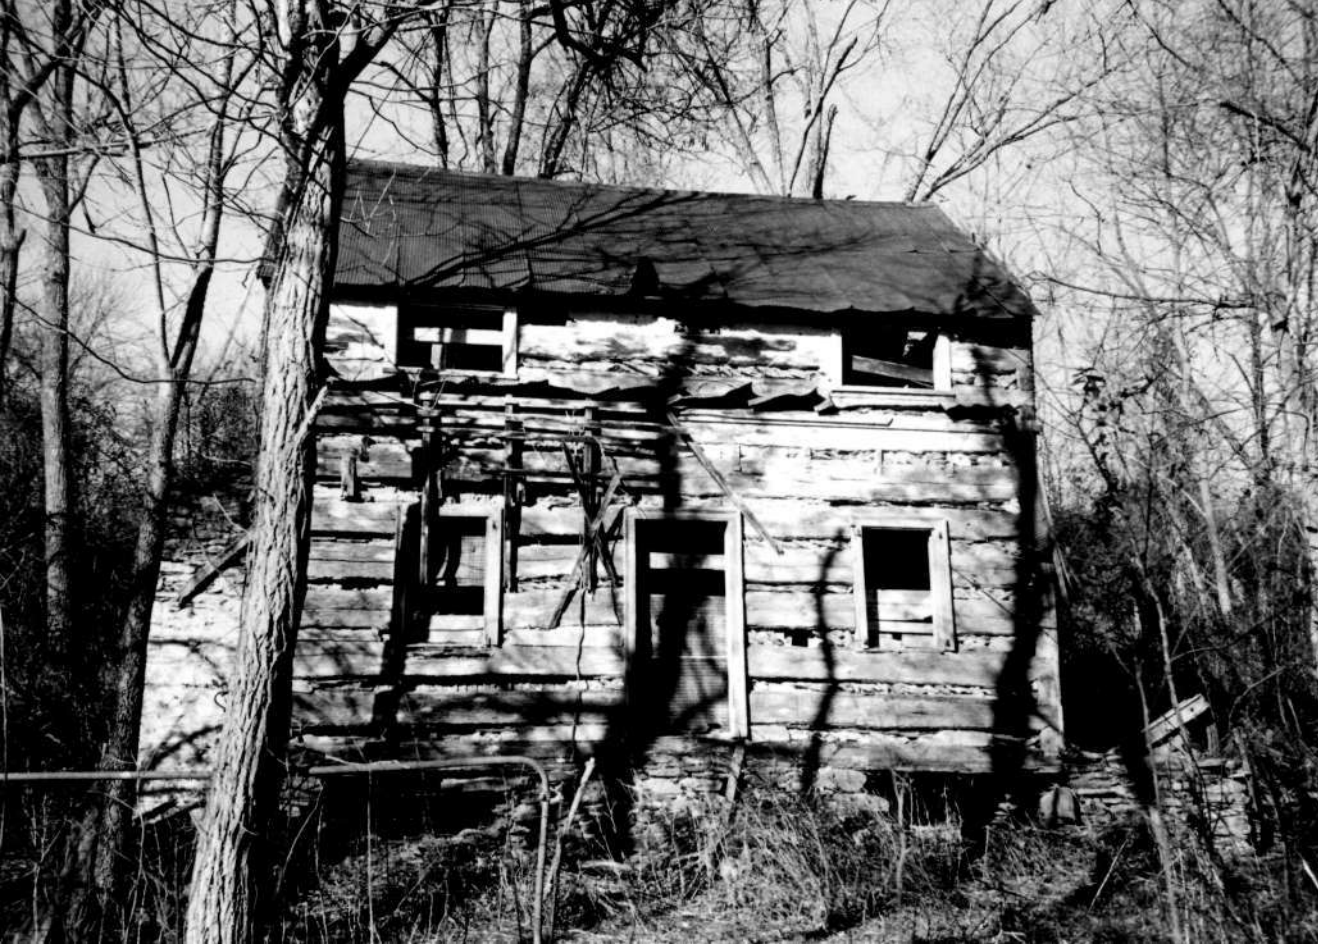
2/23

The symmetrical front façade is comprised of four window openings, two on each story, and a central entrance door on the first floor. The windows on the second story are the same width as those on the first story, but not as tall as those on the first story. The remnants of a frame-and-tin, shed-roof porch are visible on the front façade.

Facade of log house, view to  
the north

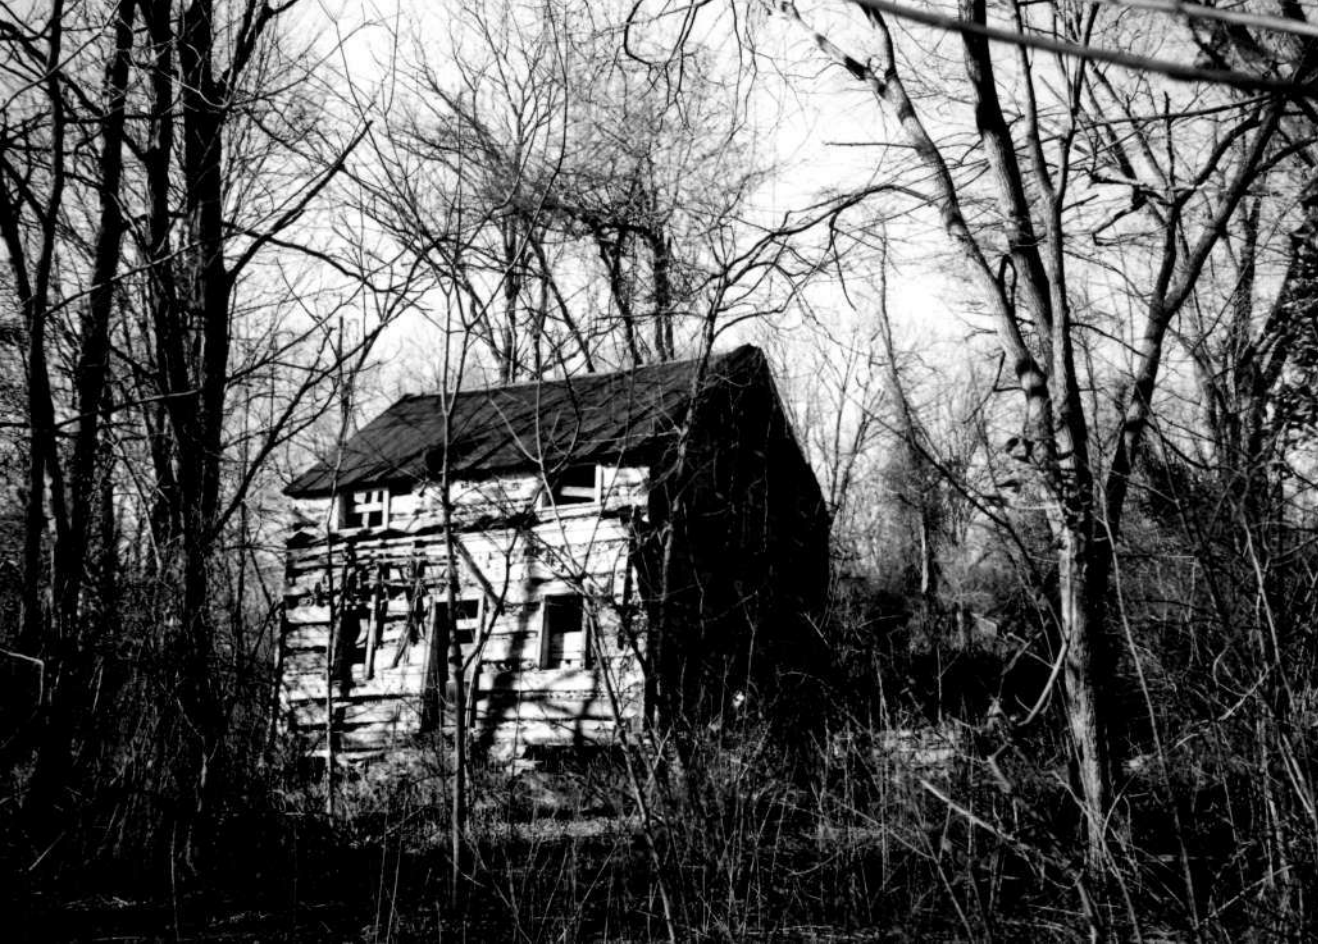
3/23

Facade and east elevation  
of the log house

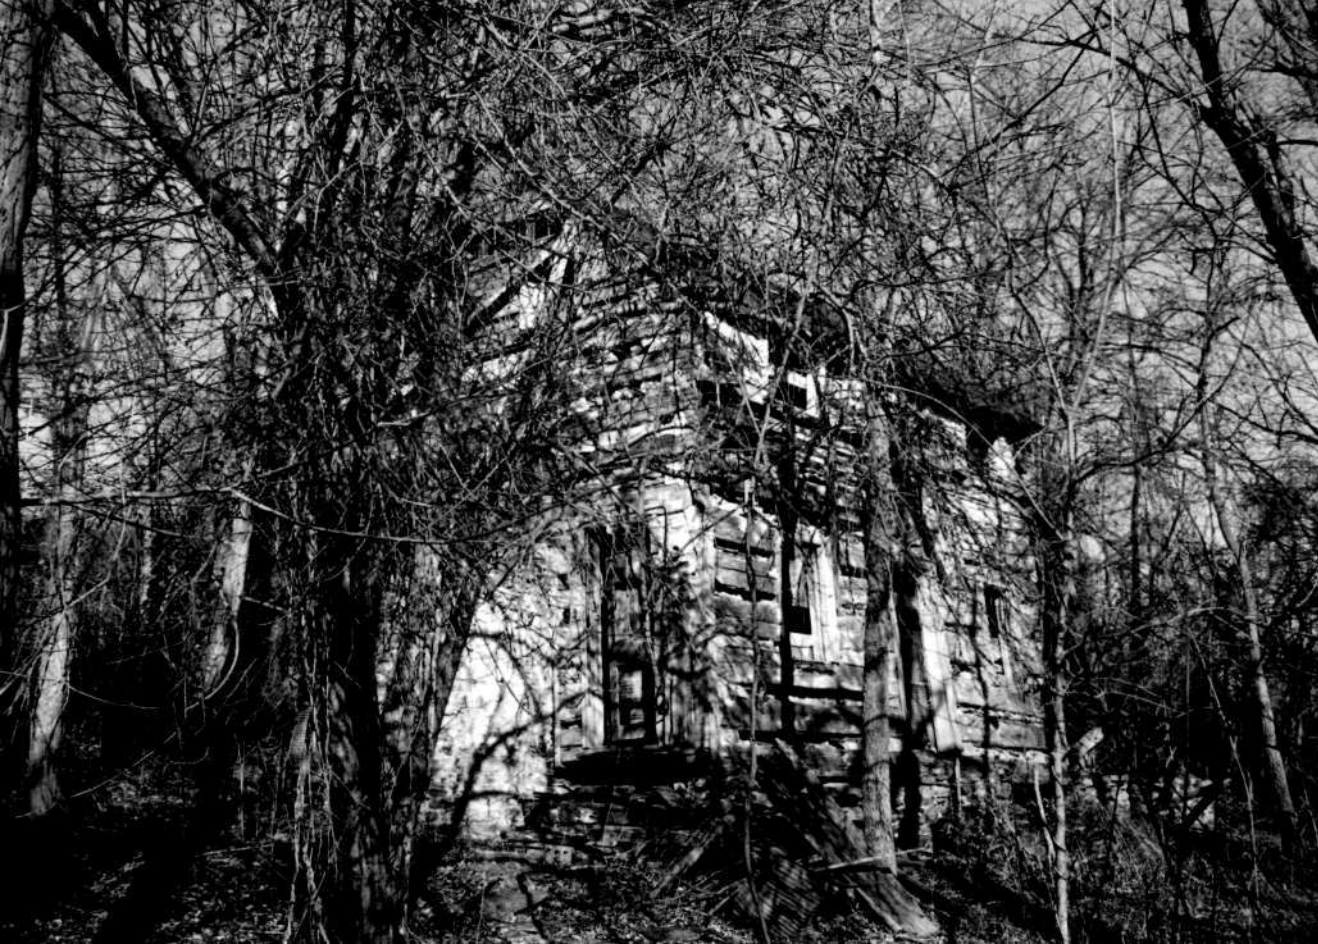
4/23

The exterior of the west elevation has the remains of a stone chimney base. The west elevation also features a side entrance. The wood door is intact, but in poor condition and has been patched with tin roof material. The remains of a stone pathway lead up to a wood staircase below the west entrance door. A pair of small, identical windows is situated between the chimney on the second story.

Facade and west elevation  
of log house; view to the NE

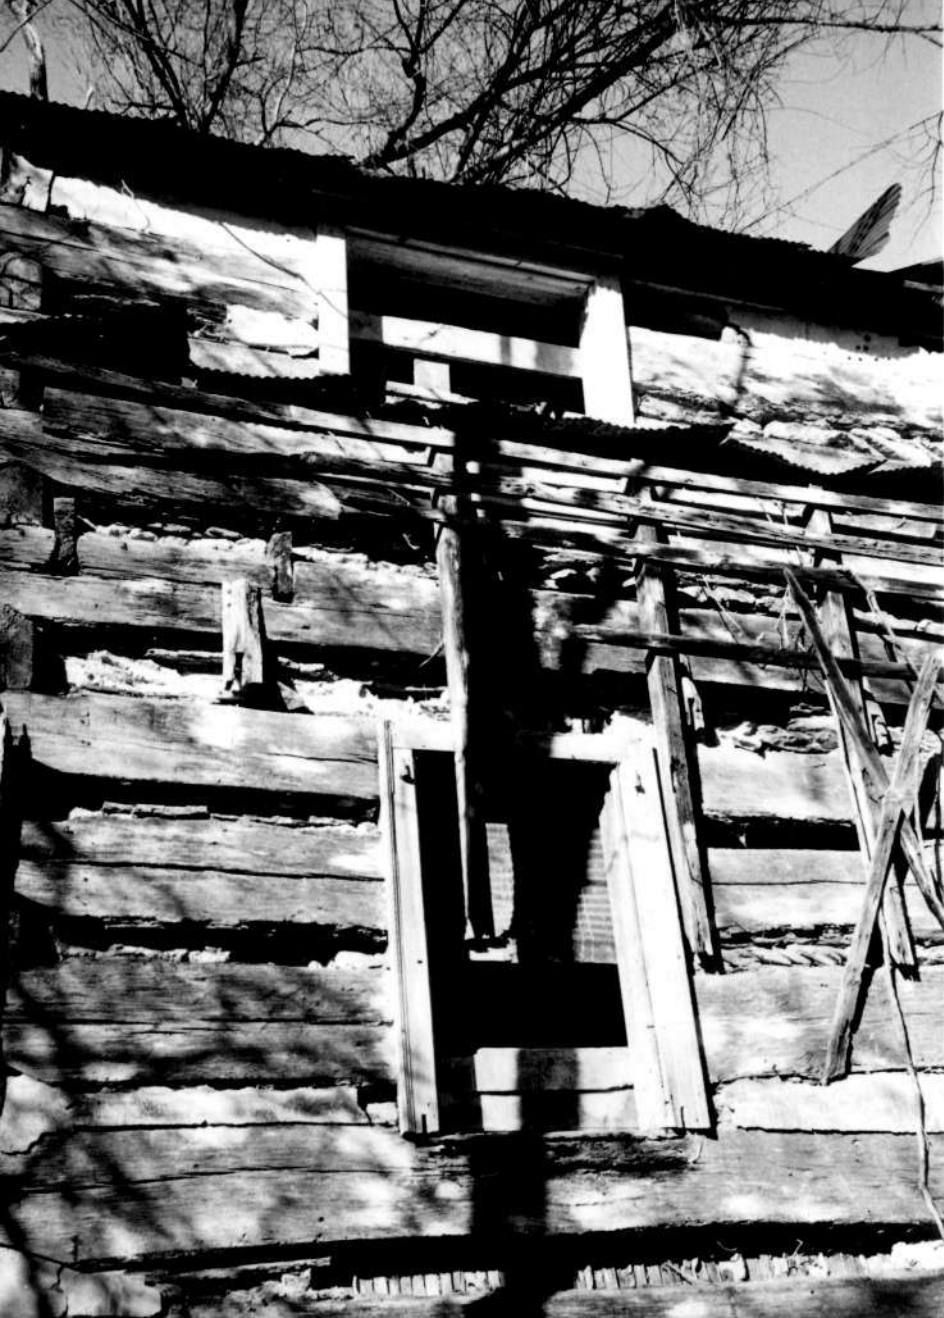
5/23

Detail of window openings on  
facade; view to the north

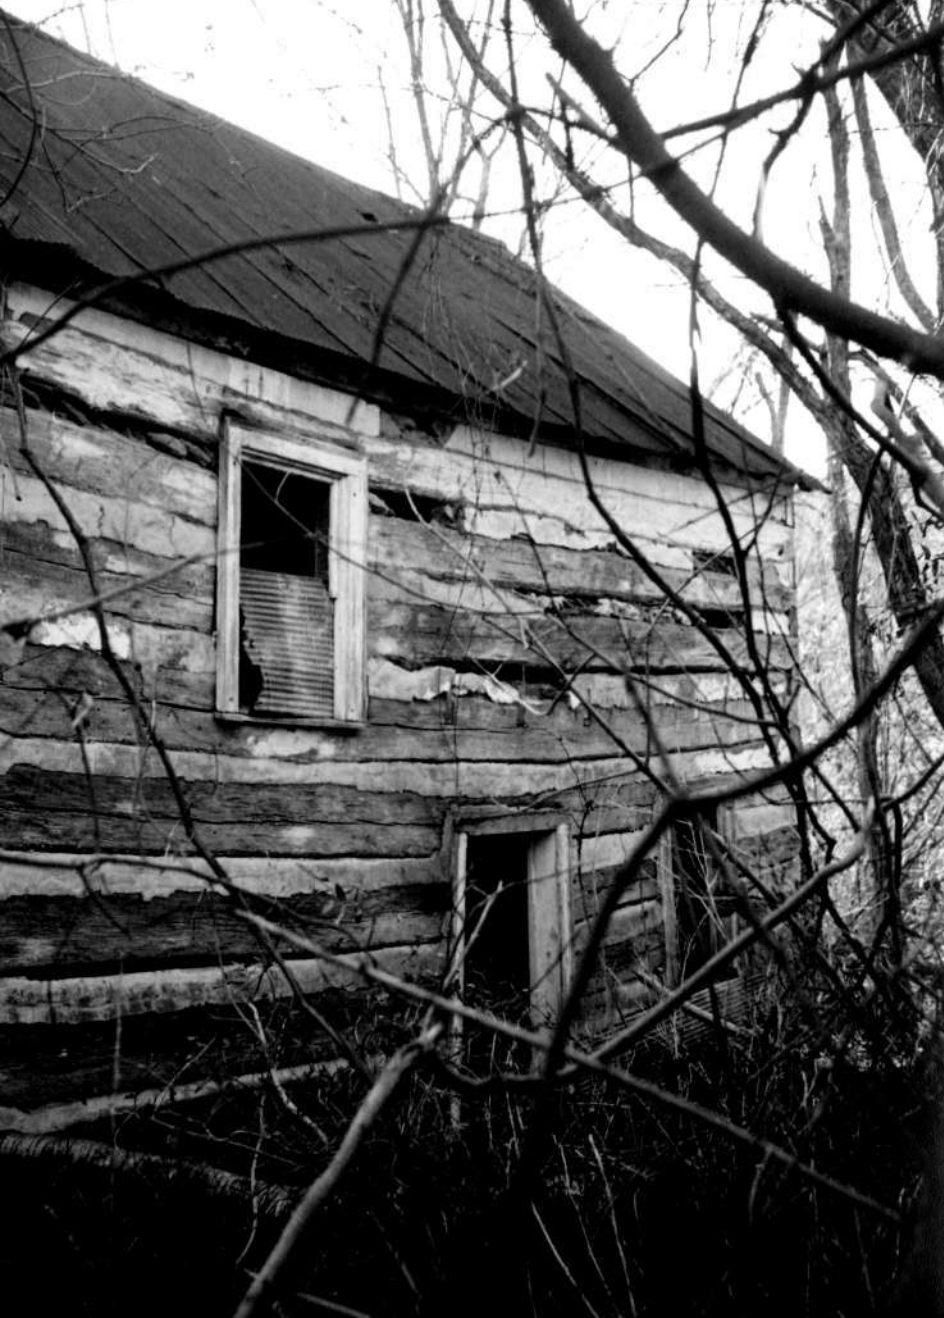
6/23

The south (rear) elevation is not a mirror image of the front façade. A central entrance door is on the first story, but only one window opening is found on the west side of the door on the south elevation. The second story features only one window on the east side.

View of rear elevation of log house,  
facing south

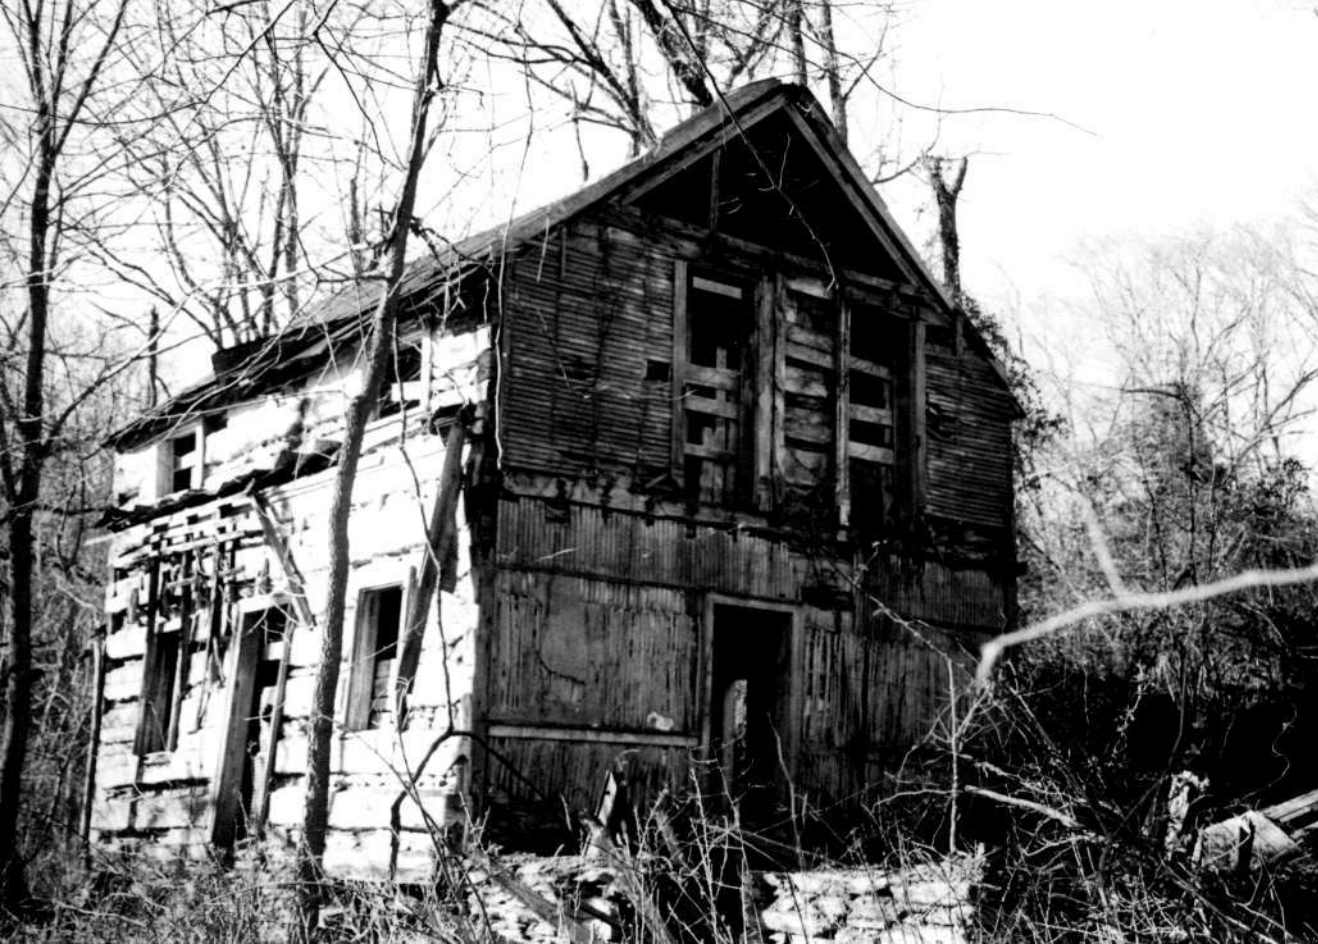
7/23

Facade and east elevation  
of log house; view to the NW

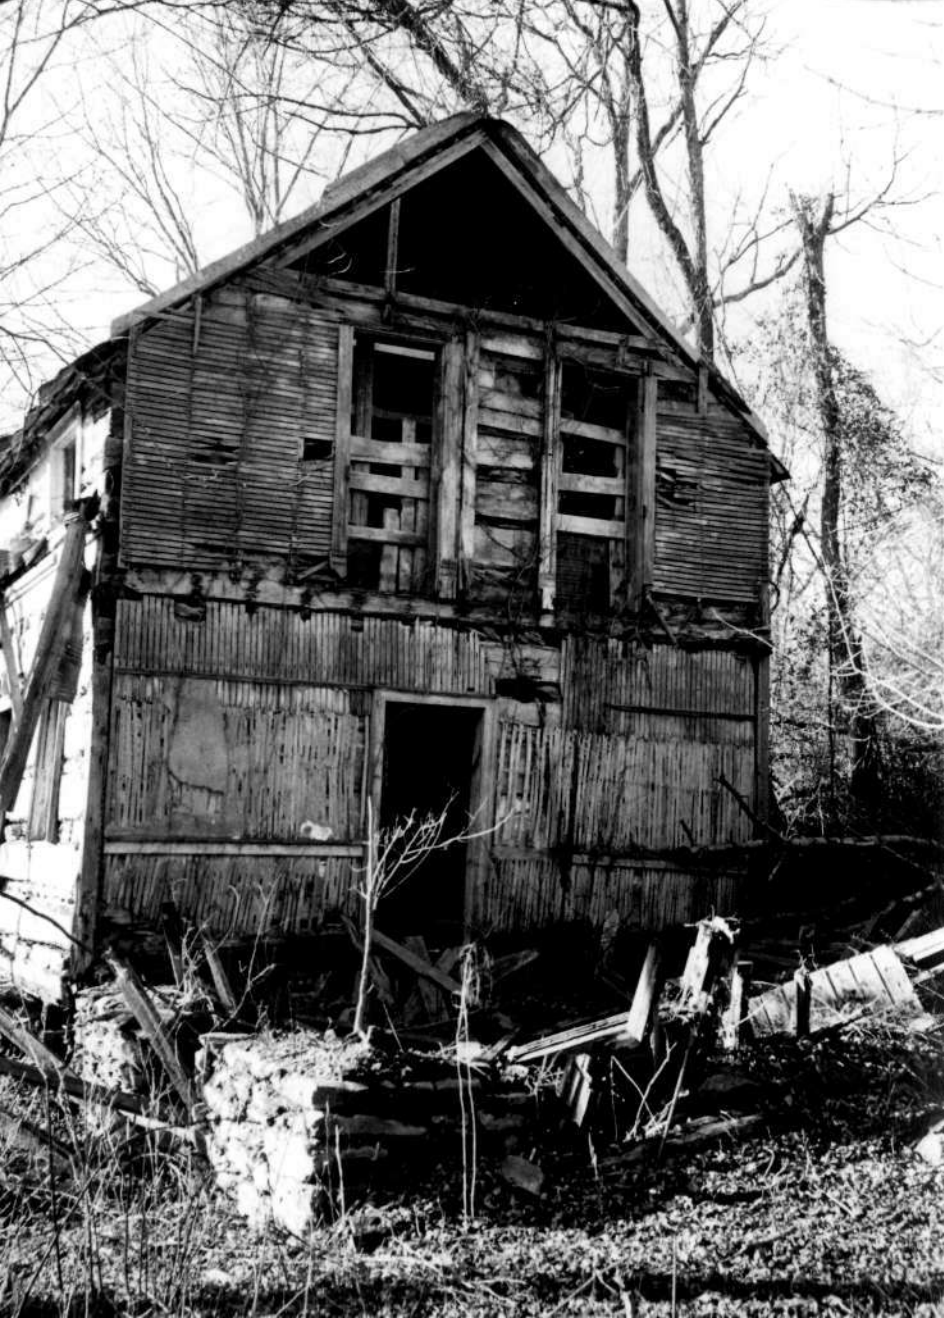
8/23

east elevation of log house

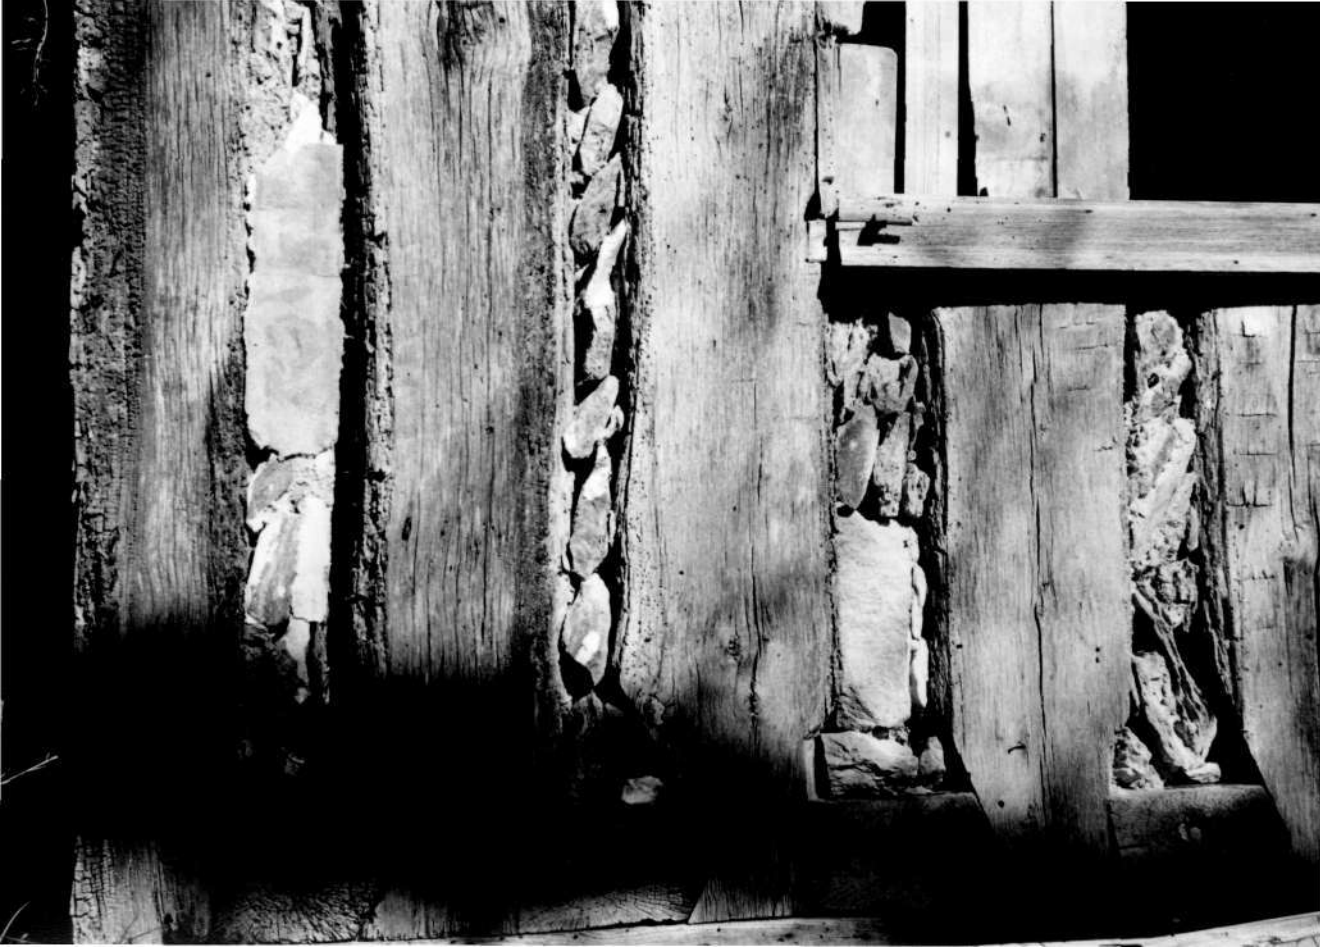
9/23

detail of facade of log house

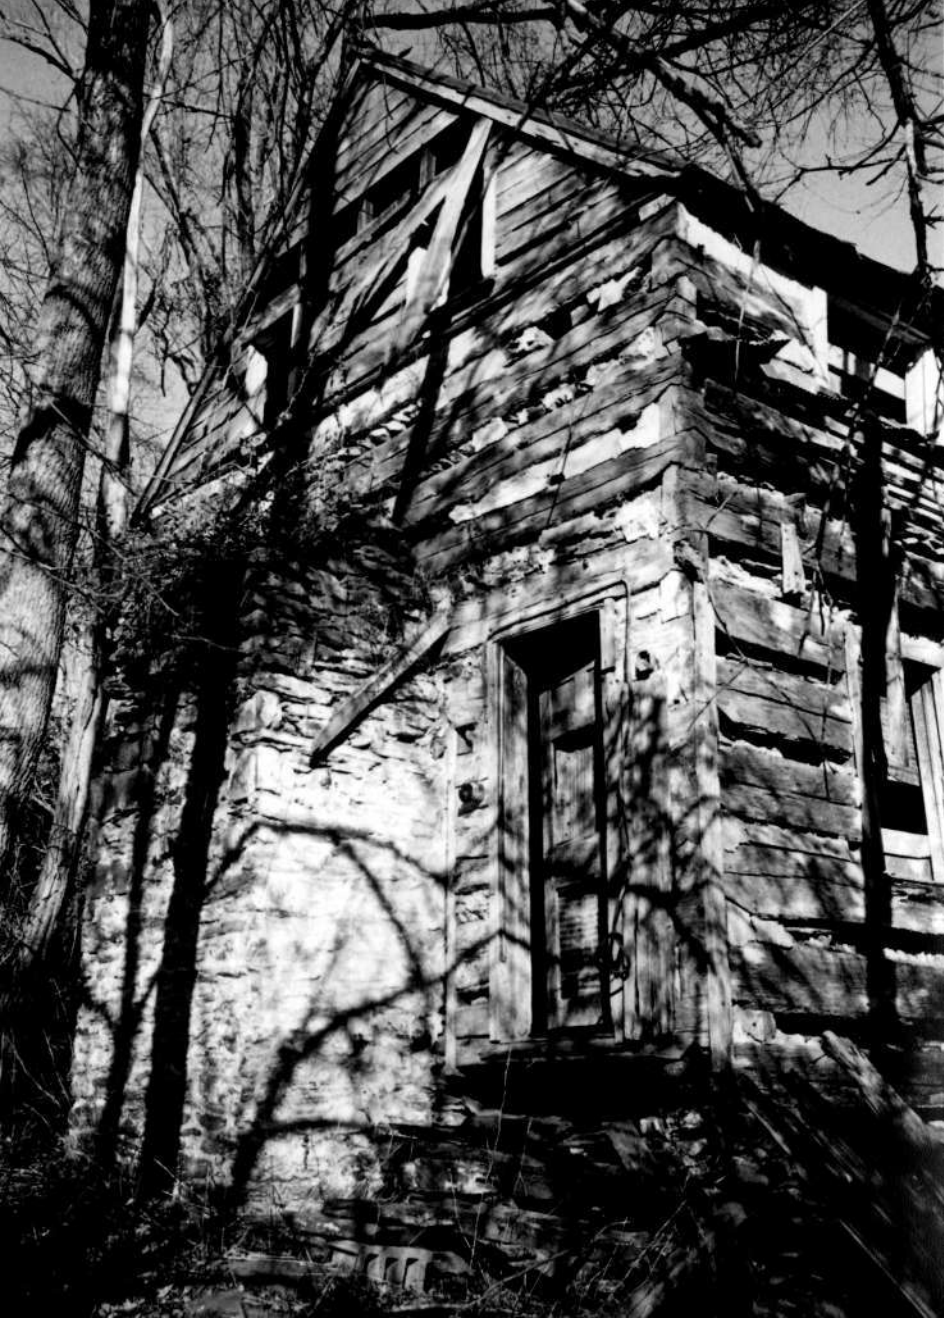
10/23

West elevation of log house

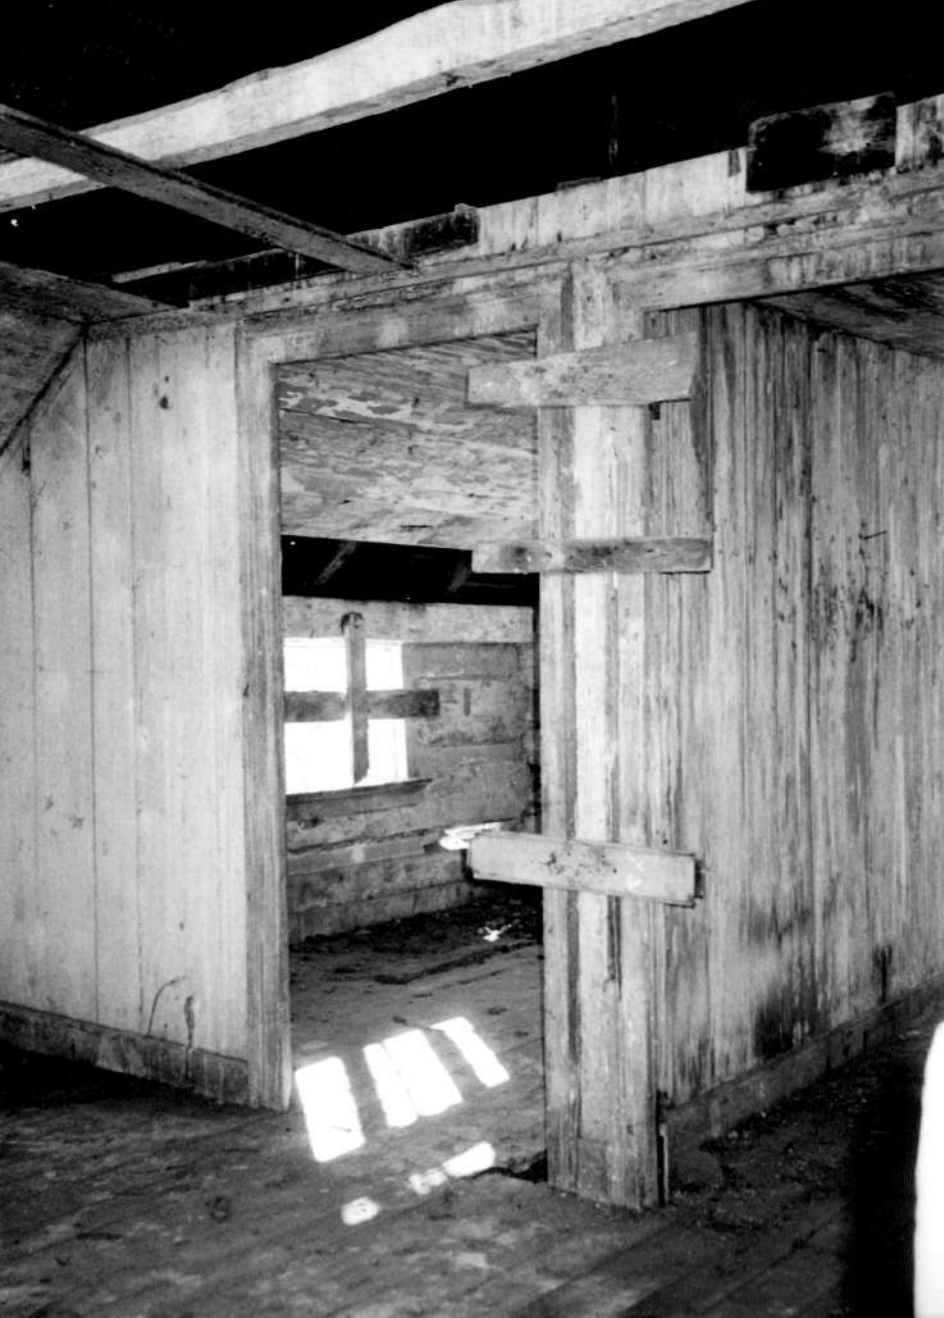
11/23

A winding staircase leads to the second-story room on the east side. This room was a corridor to the second story of the adjoining wood-frame addition, which is now in ruins. The walls and ceiling of the two, small bedrooms on the west side of the second story are tongue-in-groove, wide, wood planks, with chips of blue and white paint attached to the surface. These bedrooms feature a chamfered ceiling on the north and south walls, indicating that perhaps the second story was a later addition. The rafter beams of the gable roof are exposed on the second story.

Second floor of log house; view to the  
SW

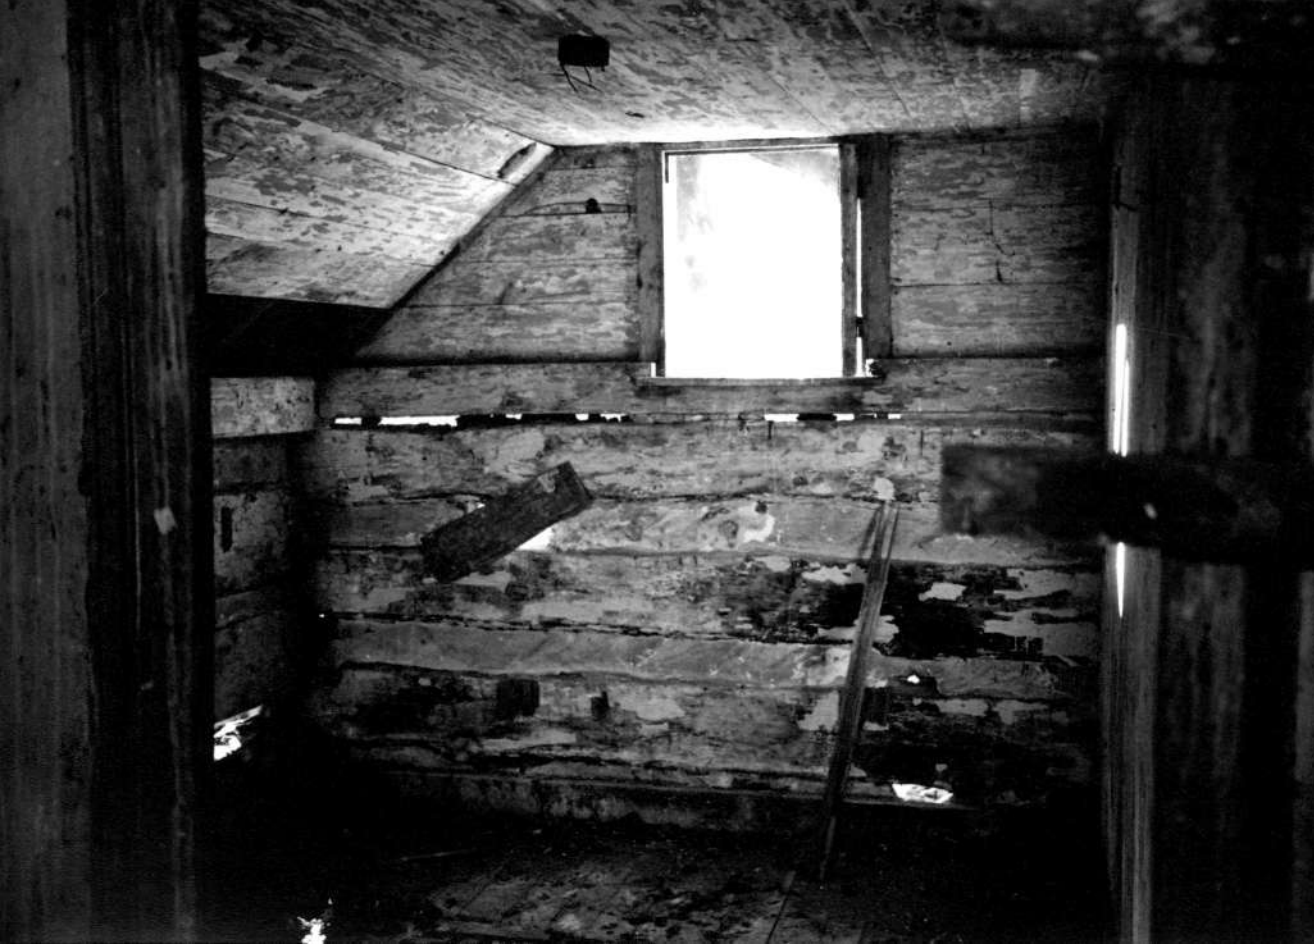
13/23

Second floor room; view to the west  
(log house)

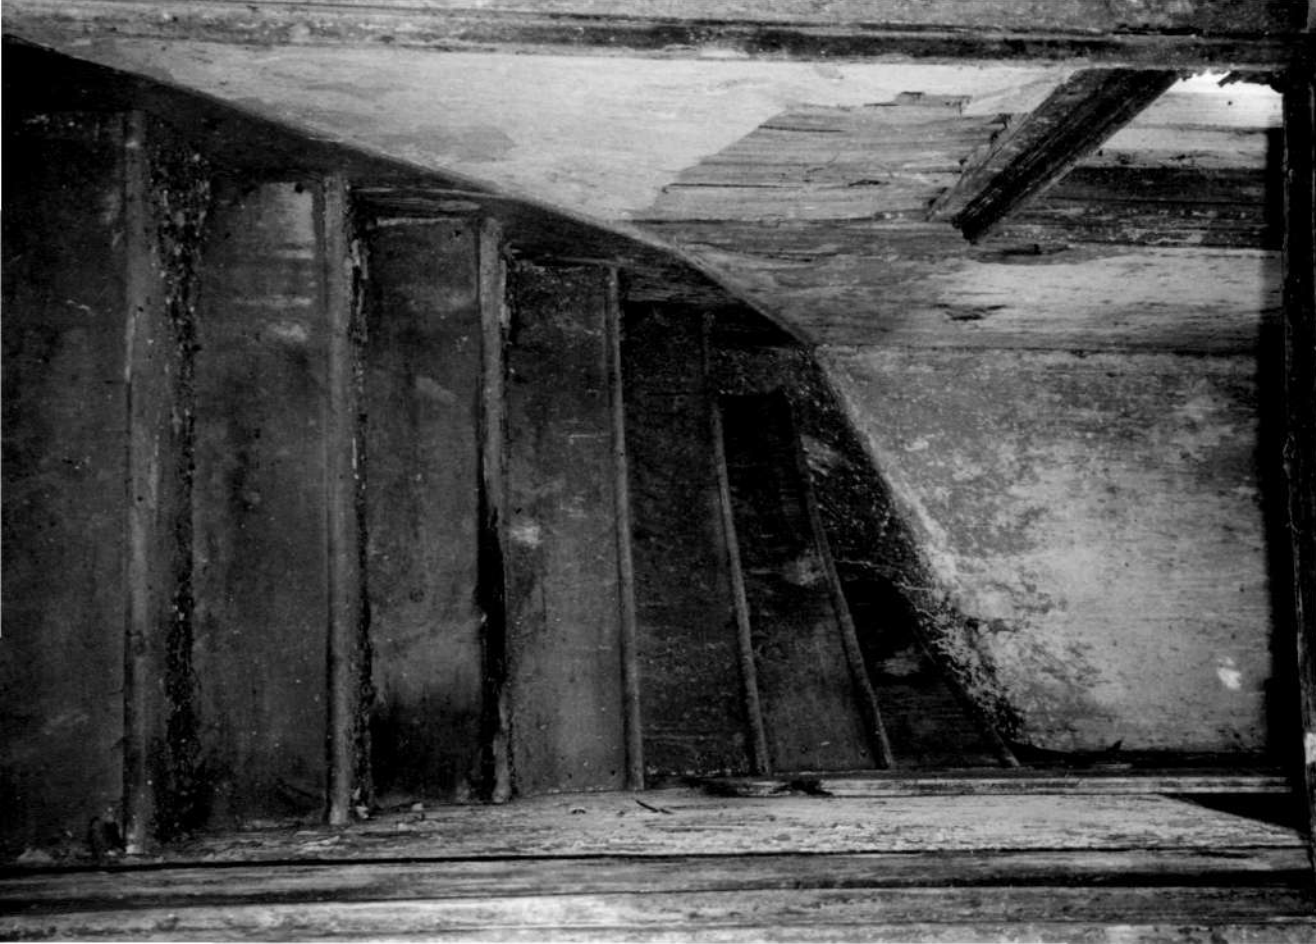
14/23

Staircase from first floor; view to the east.  
(log house)

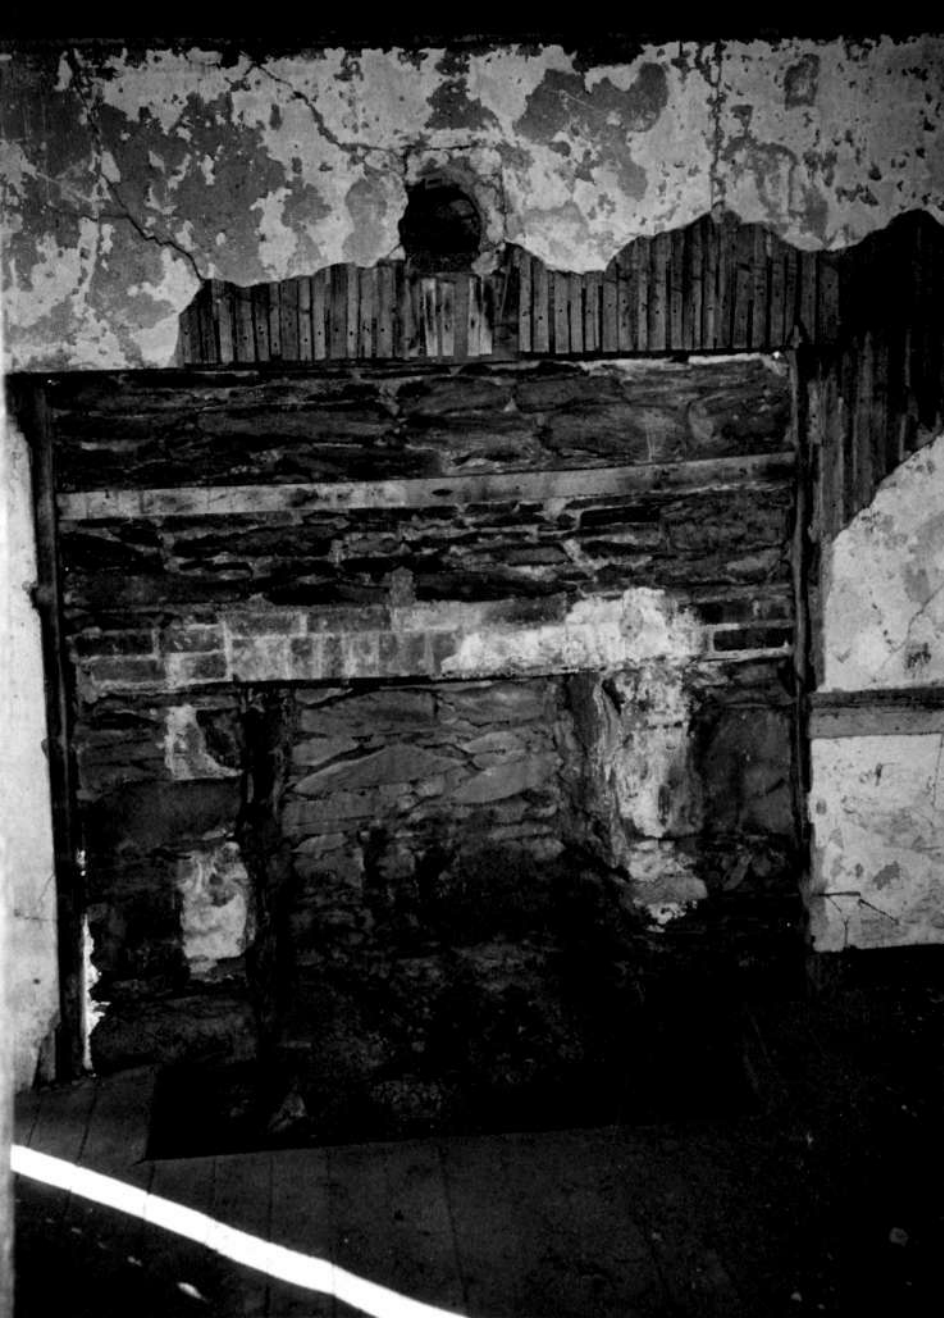
15/23

To the west of the main entrance is a room which contains the only fireplace in the house, and there are remnants of wide, chair-rail molding on the walls in this room. The fireplace hearth is constructed of field stone. The stone hearth is very similar in appearance to the stone foundation of the collapsed wing addition on the east elevation of the log house. The hearth is accented with a flat, dressed, stone slab that appears to have been the location of the mantelpiece and two lintel courses of red, brick headers and footers that span the width of the fireplace surround. An area of exposed wood slats is directly above the fireplace, revealing the same vertical alignment as seen on the exterior of the east elevation. The interior of the opposite room, on the east side, consists of the same wide, chair-rail molding as in the west room, but also contains a closet space below the staircase, which leads to the second floor. In both rooms, the interior dividing walls between the rooms are comprised of wide wainscoting. This same construction is featured on the closet wall below the staircase and on the second-story, interior walls.

Fireplace; first floor; view to the west

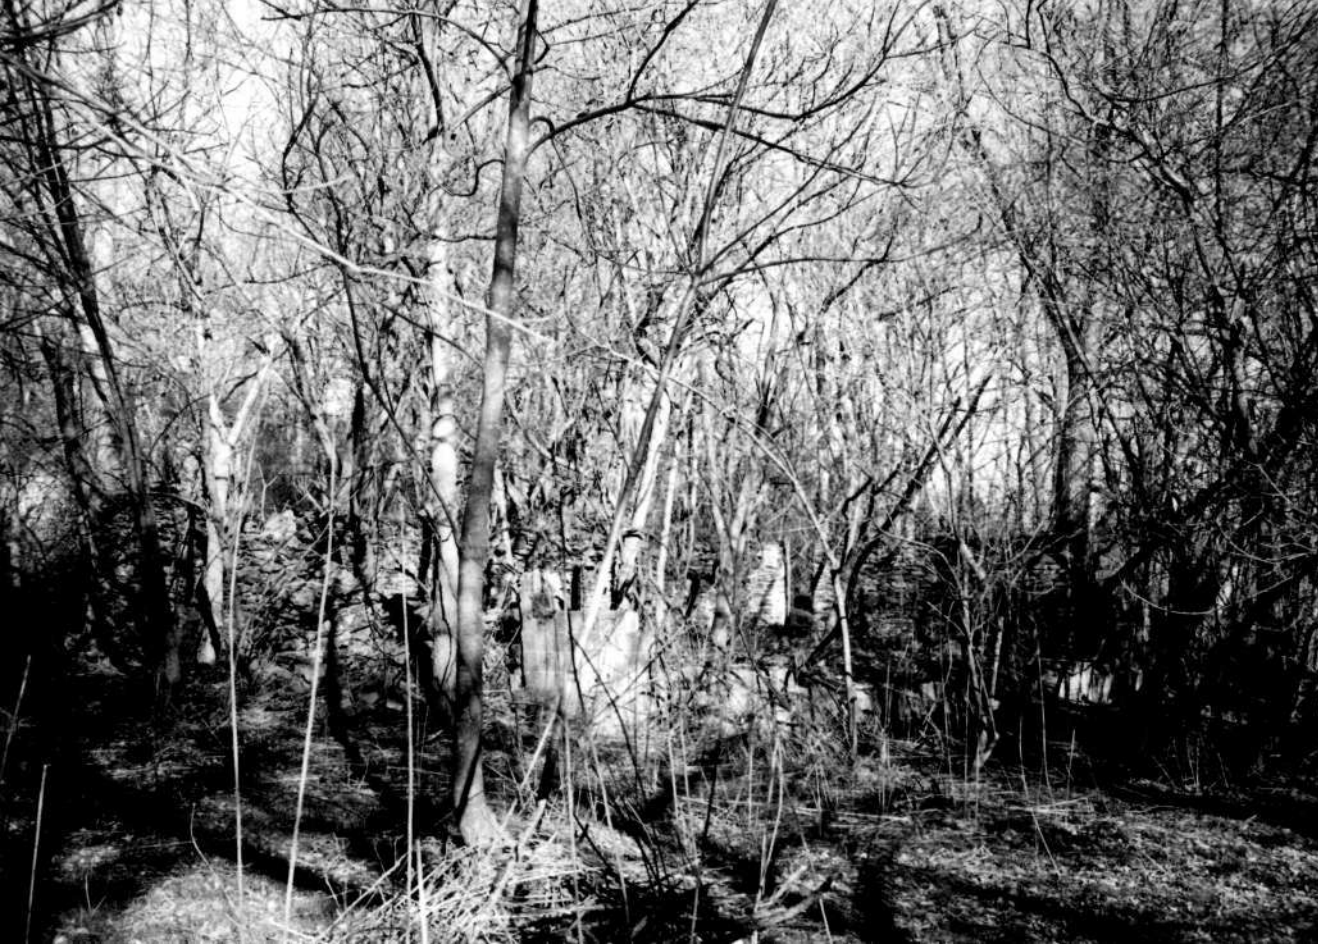
16/23

The field-stone and cinder-block foundation is all that remains of the bank barn, which is located to the southwest of the log house. It appears that the cinder blocks were used to enclose the original overhanging forebay (photos on file at SHA, file No. 45824). A poured-concrete trough is located on the ground in the center of the barn. It was once used to keep the interior of the barn free of livestock excrement, as it functioned as a waste receptacle. The trough was easy to maintain by simply hosing the waste matter out the trough. Currently, the foundation is collapsed in sections and heavily overgrown with trees, the superstructure is gone; therefore, the barn no longer conveys its original association with the farmstead.

View of bank barn foundation;  
view to the NW
